DS40& DS80 PRINTERS: SQUEAKS WHEN PRINTING

Overview

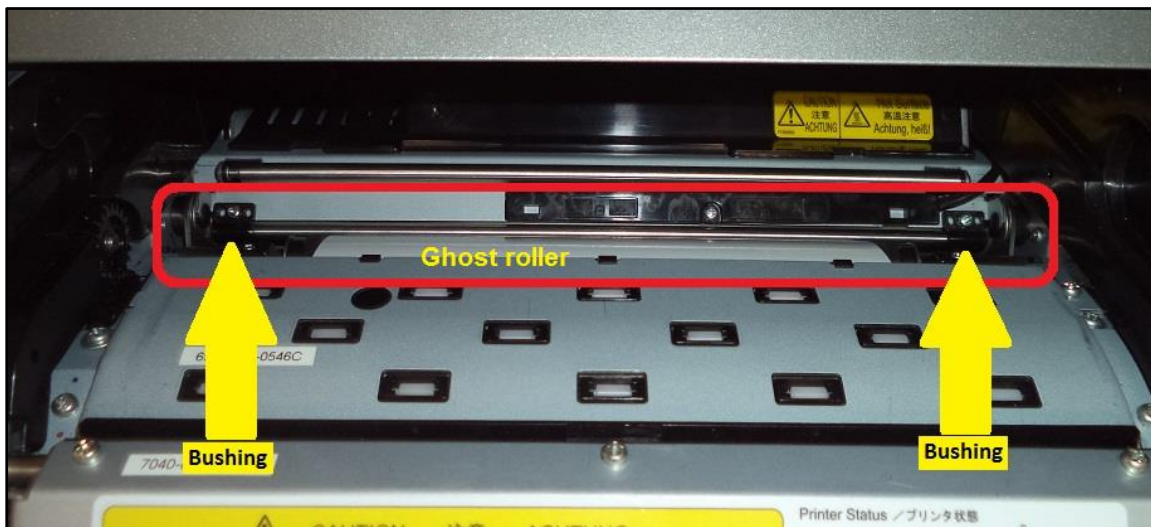
The DS40 and DS80 printer may emit a loud squeaking sound during printing when dirt or debris gathers in the ghost roller bushings. Cleaning the roller and bushings eliminates the squeaking.

1. Turn off the printer and unplug it to prevent possibility of electric shock.
2. Open the printer by gripping the blue handle below the front of the printer and pulling the drawer forward.
3. Remove the ribbon cassette.
4. Locate the ghost roller in the front of the ribbon compartment at the bottom. It is the silver roller closest to the front of the printer. The ends are held by black bushings screwed to the base.

5. Remove the screws holding the bushings, one on each end of the roller.
6. Remove the bushings and the roller. The bushings are slipped on the ends of the roller and will easily slip off.
7. Clean the rollers especially the ends and insides of the bushings with a cotton swab and rubbing alcohol.
8. Replace the roller and bushings and secure the screws.
9. Reload the printer and test.
